Effect of contact pressure on fretting fatigue behavior of Ti-1023

Wu, G. Q., Liu, X. L., Li, H. H., Sha, W., & Huang, L. J. (2015). Effect of contact pressure on fretting fatigue behavior of Ti-1023. *Wear*, 326-327, 20–27. <https://doi.org/10.1016/j.wear.2014.12.033>

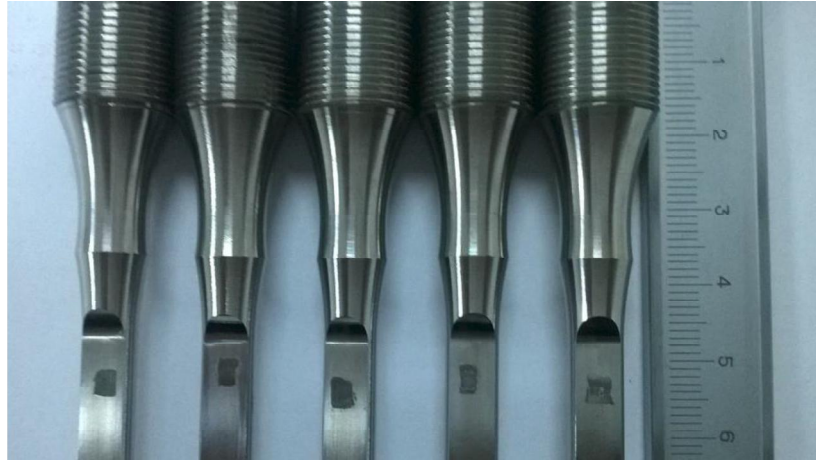
Fig. 2. Photographs showing the wear damaged areas before fracture, after 10^7 cycles.
Contact pressure 3 MPa, 5 MPa, 10 MPa, 20 MPa, and 45 MPa from left to right.
